IQ-1000 Wiring Changes

June 1990

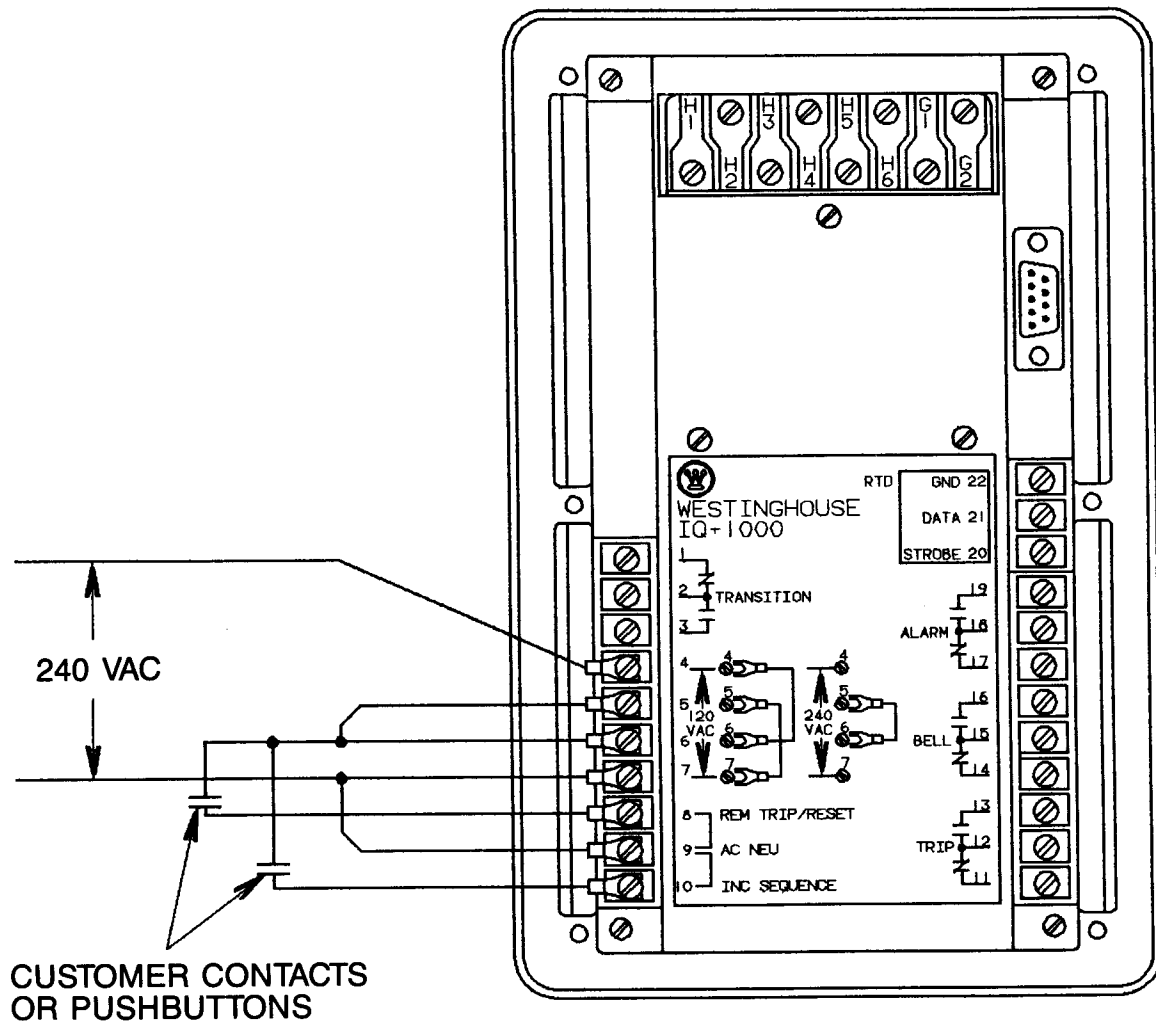
INPUT WIRING FOR 240 VAC CONTROL POWER

On page 19, in the first "NOTE" box, the manual indicates the incorrect jumper wiring to disable the Incomplete Sequence for 240 VAC operation. Damage to the IQ-1000 may result if the jumpers are wired according to page 19. For the correct wiring connections, jumpers should be installed between terminals 6 and 10 and between terminals 5 and 7. This wiring configuration is shown correctly in the figure on page 61 of the technical manual. A wiring diagram has also been included with this letter.
